Detailed Project Report
Beaver Brook, Keene, New Hampshire

Supporting Documentation

Flood Damage Reduction

FEBRUARY 1984

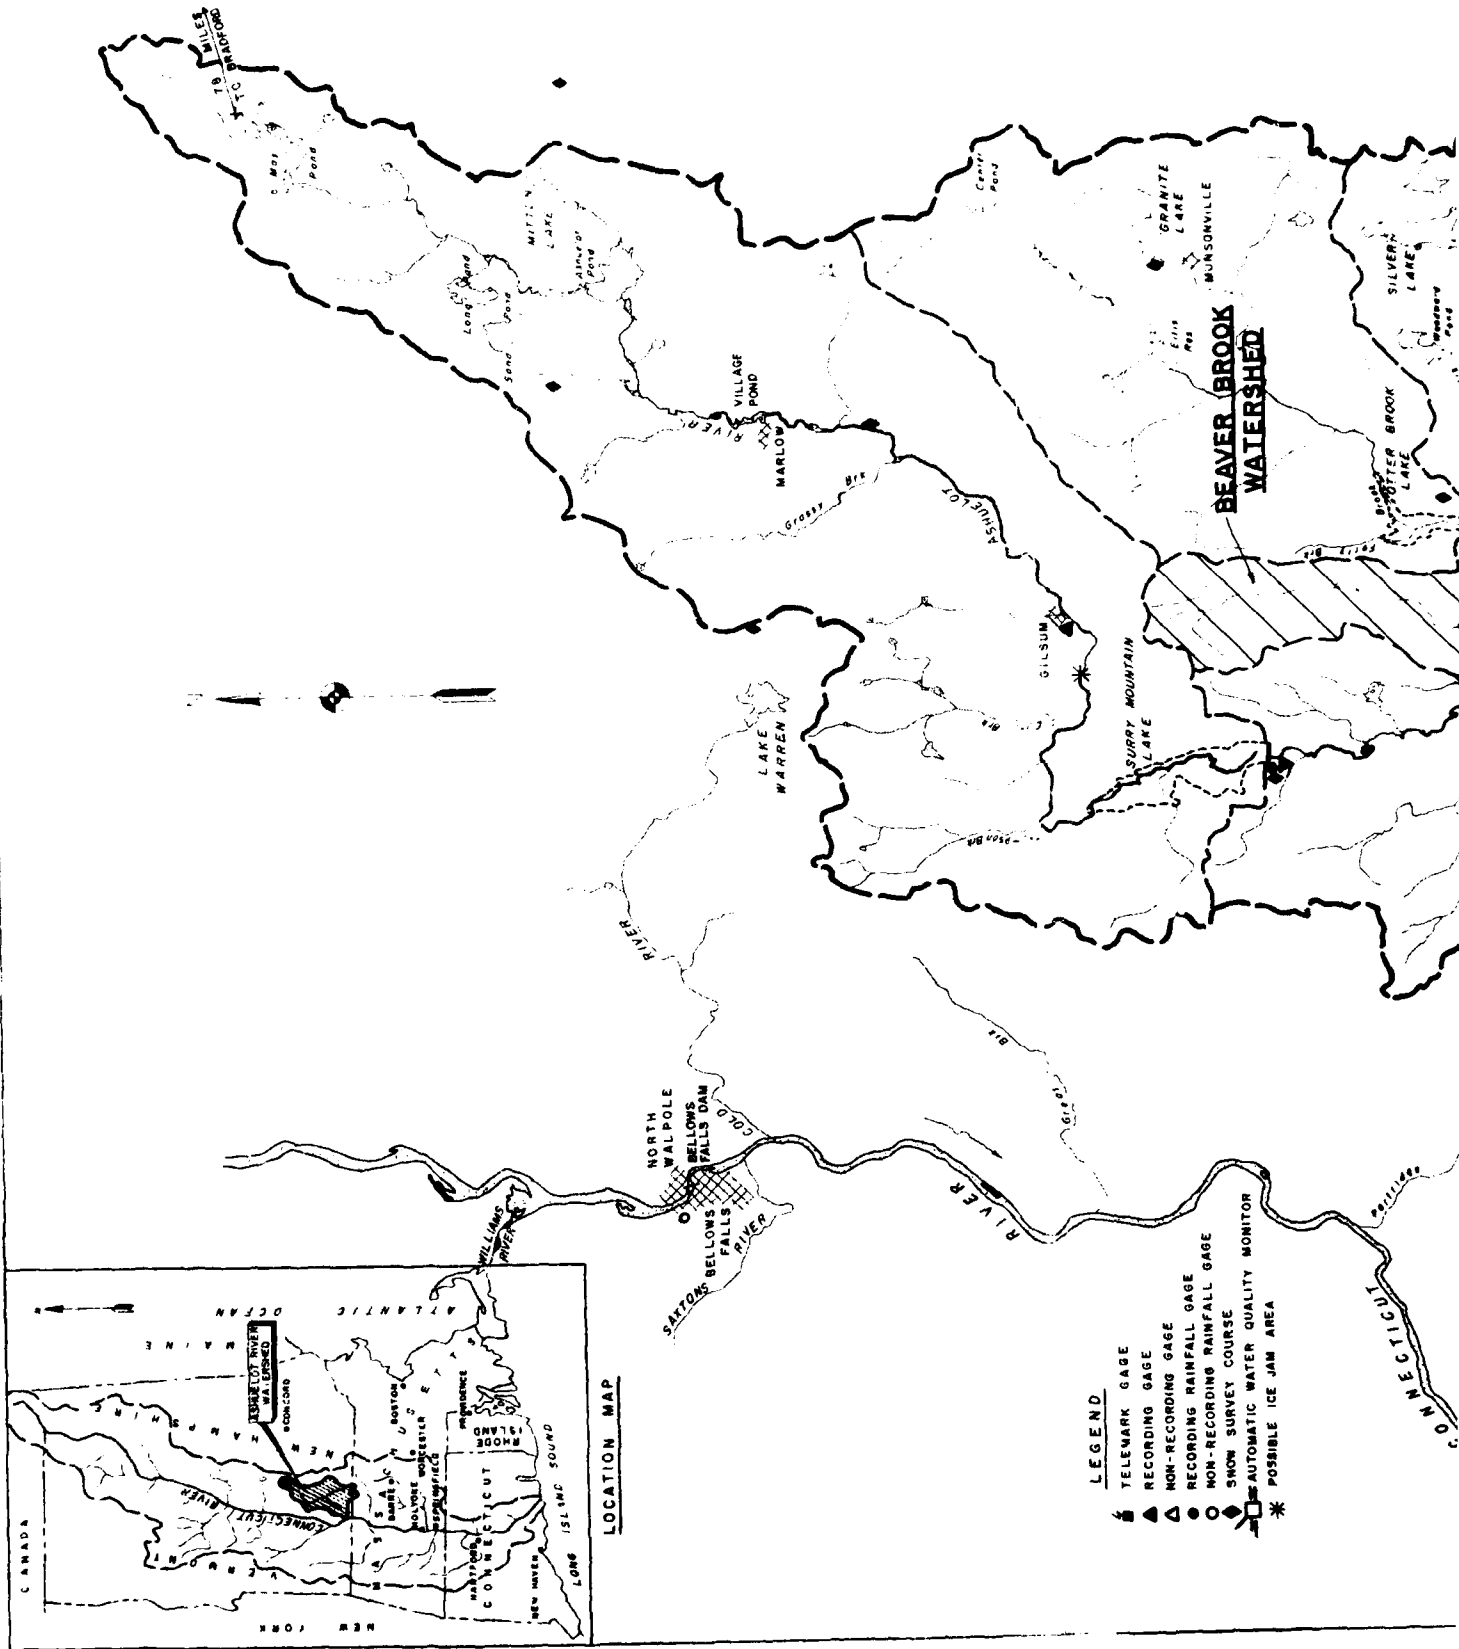
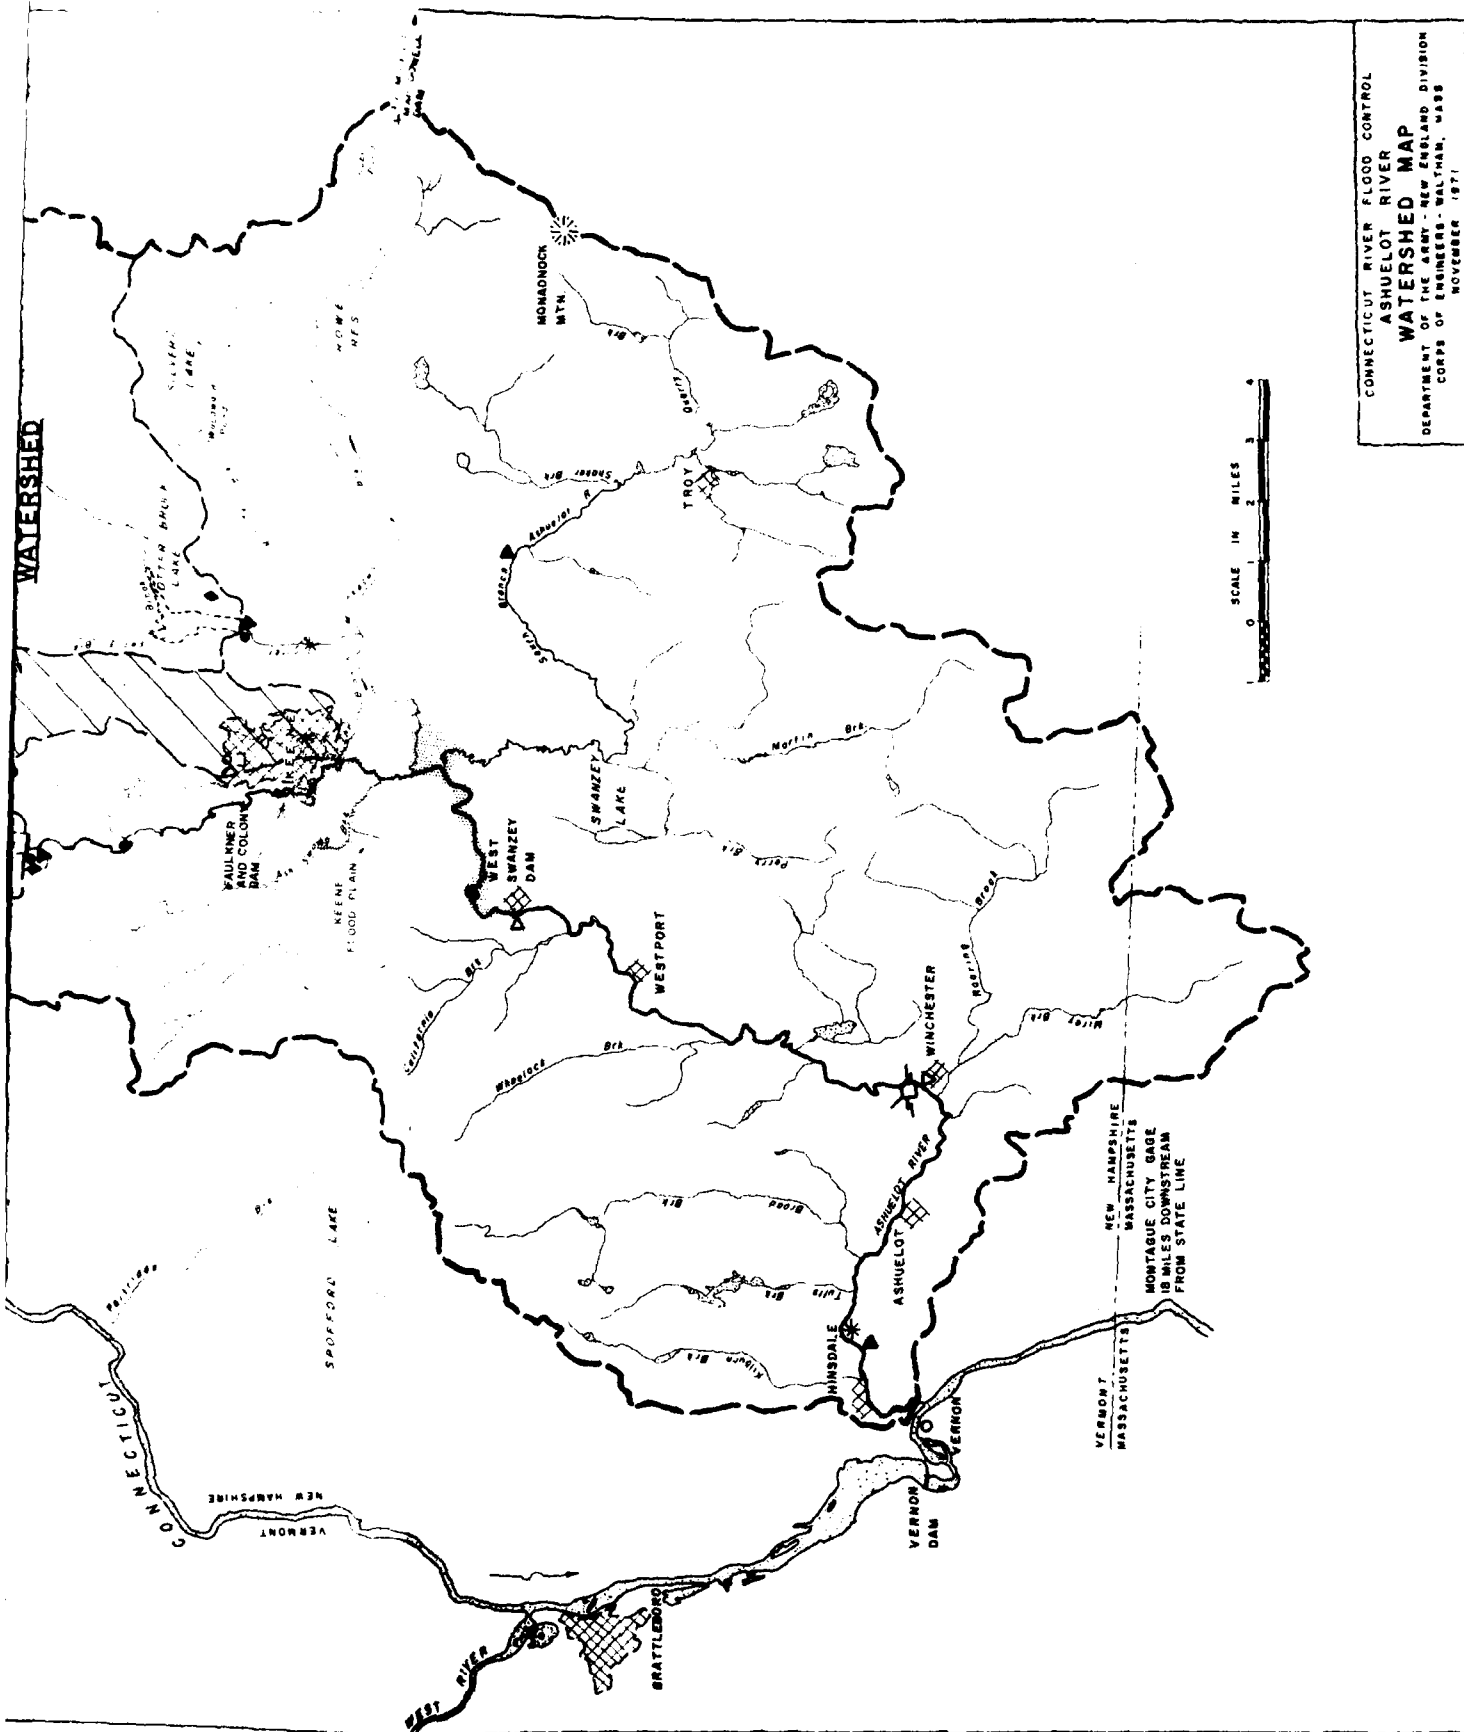
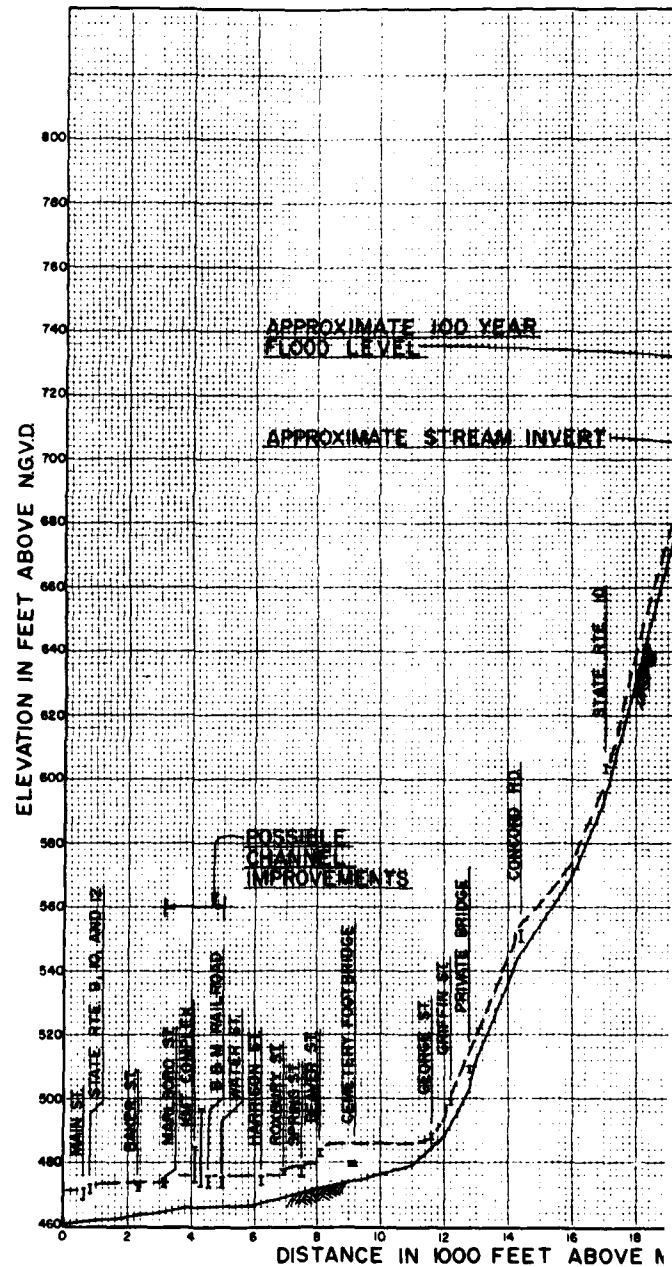
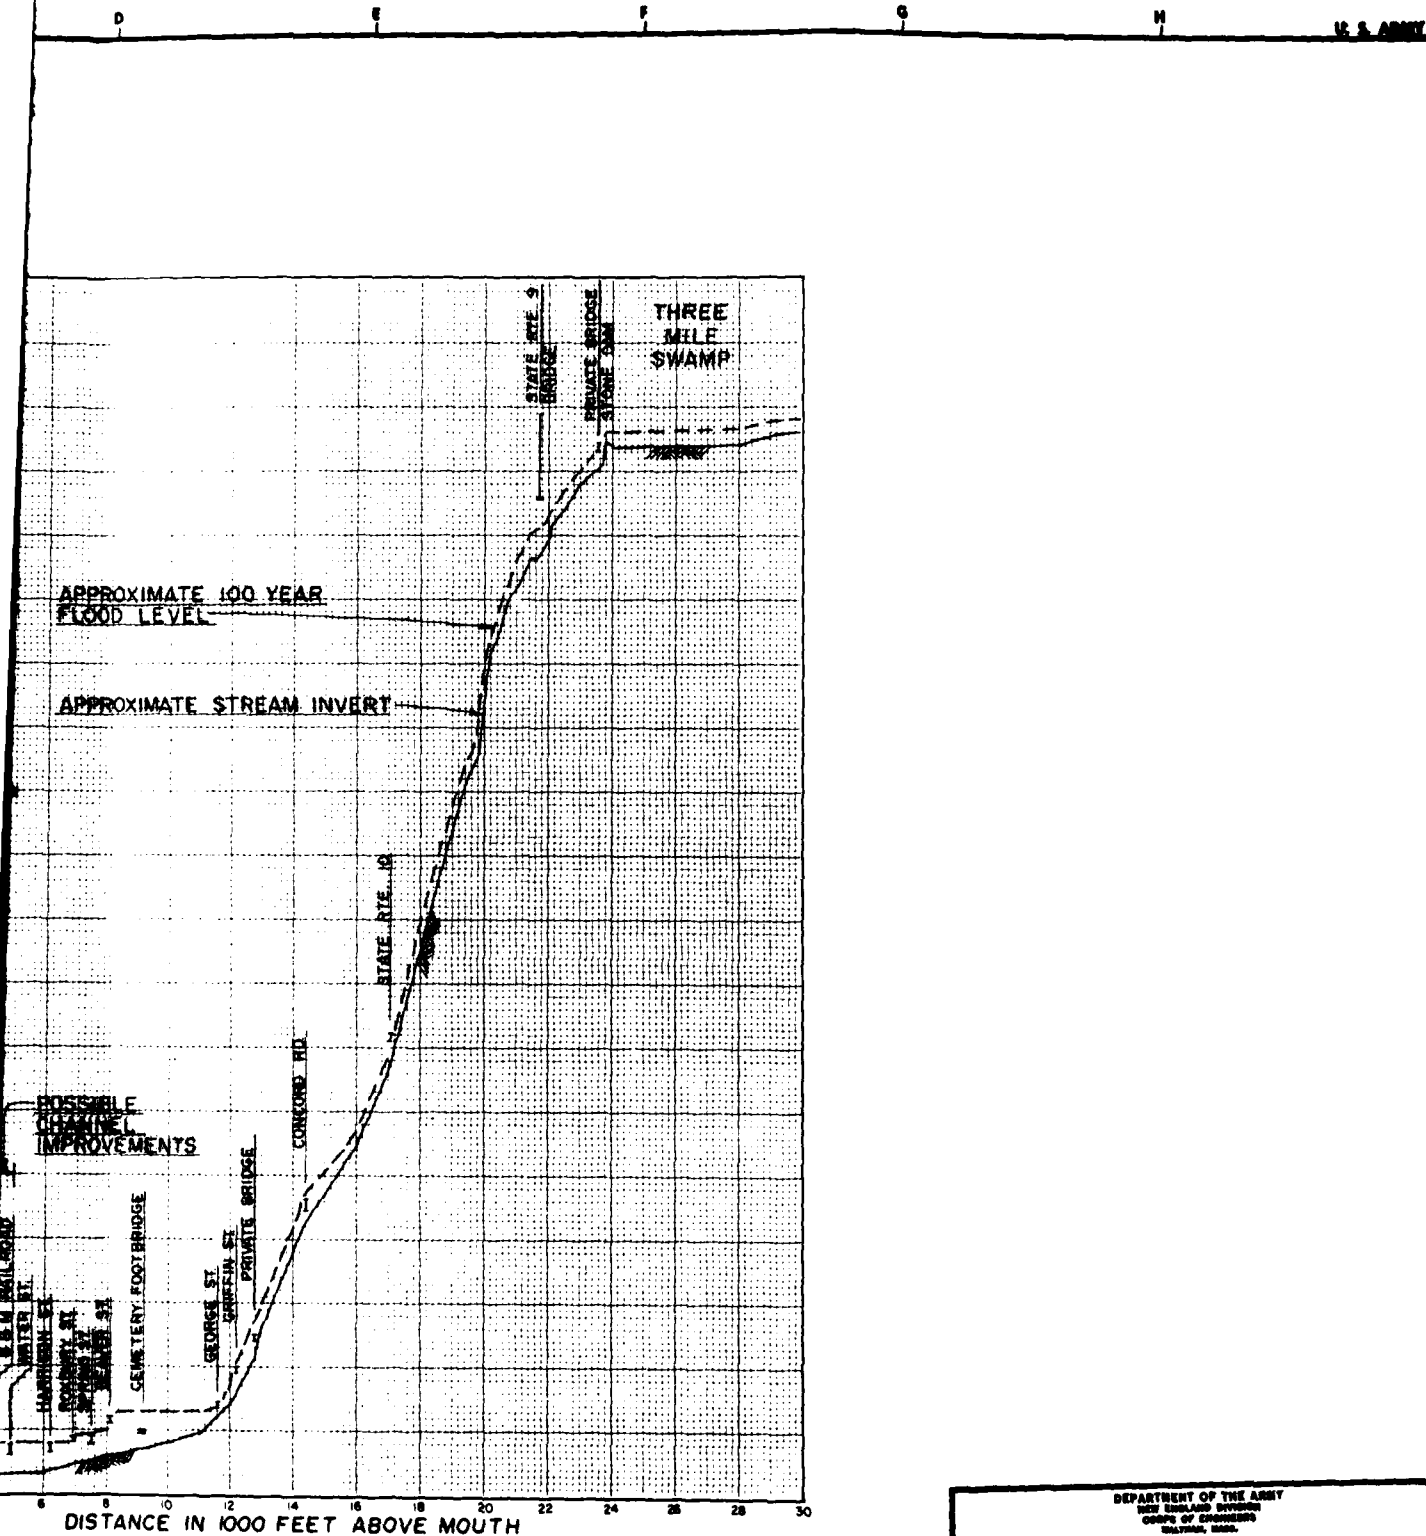
ASHUELOT RIVER BASIN
BEAVER BROOK KEENE, N.H.
BEAVER BROOK WATERSHED MAP AND
PROFILE

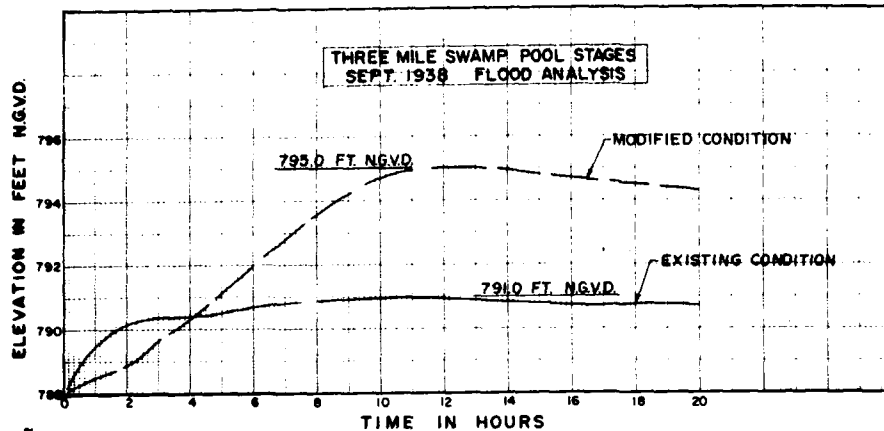
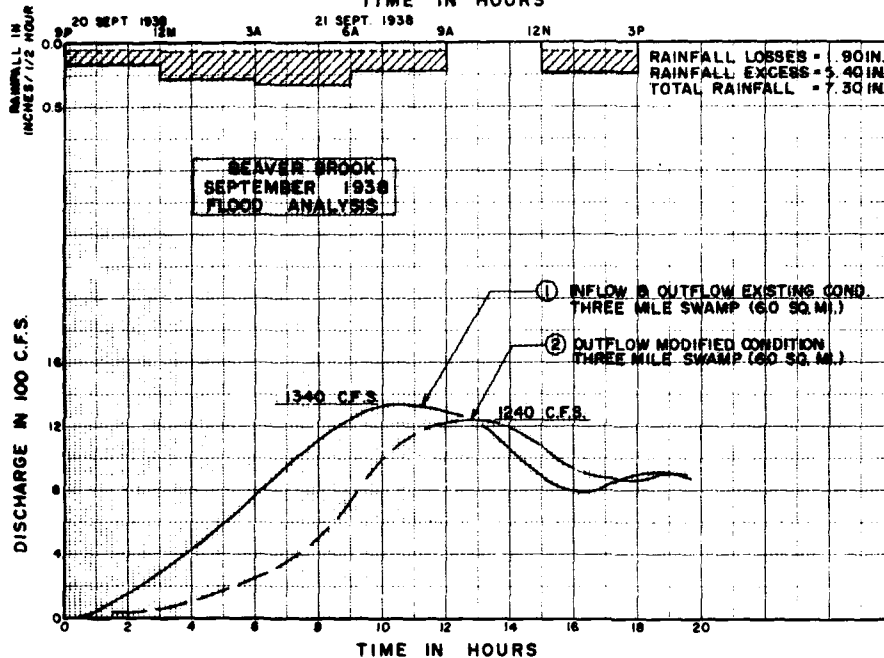
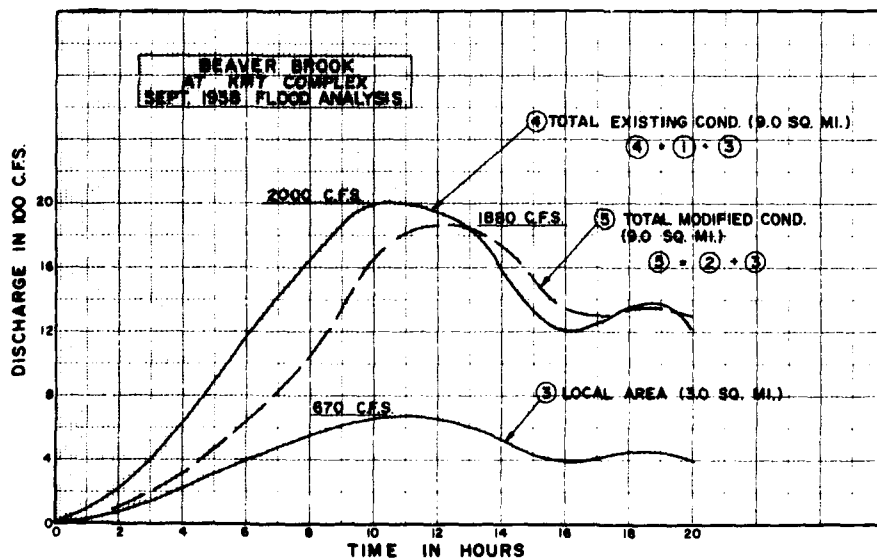
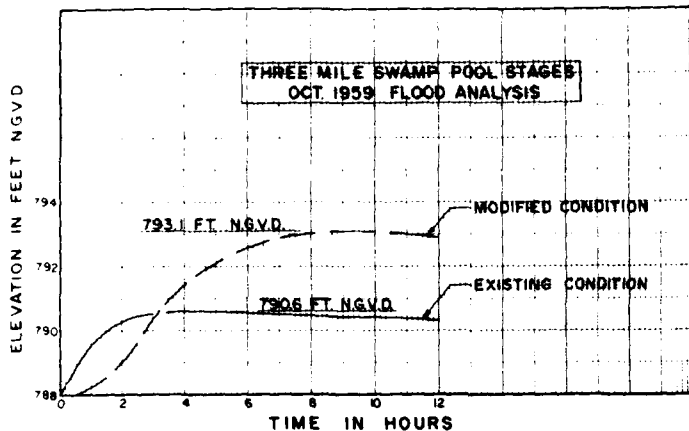
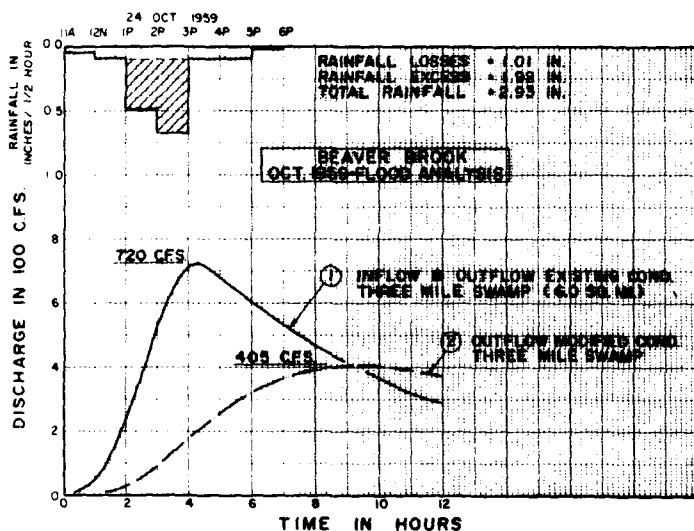
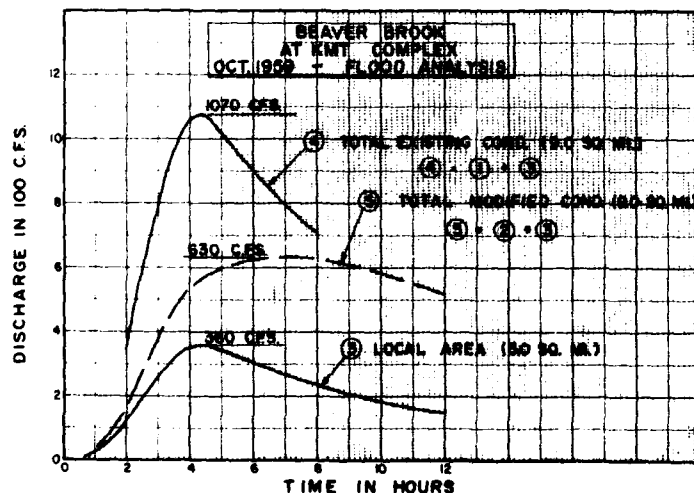
NOTES:
MINIMUM INVERT OF EXISTING AND MODIFIED
OUTLET OF THREE MILE SWAMP AT
ELEVATION 787 FT. N.G.V.D.

ASHUELOT RIVER BASIN
BEAVER BROOK - KEENE, N.H.
ANALYSIS OF FLOODS
SEPT. 1938 & OCT. 1959
HYDRO. ENG. SECT. FEB. 1960

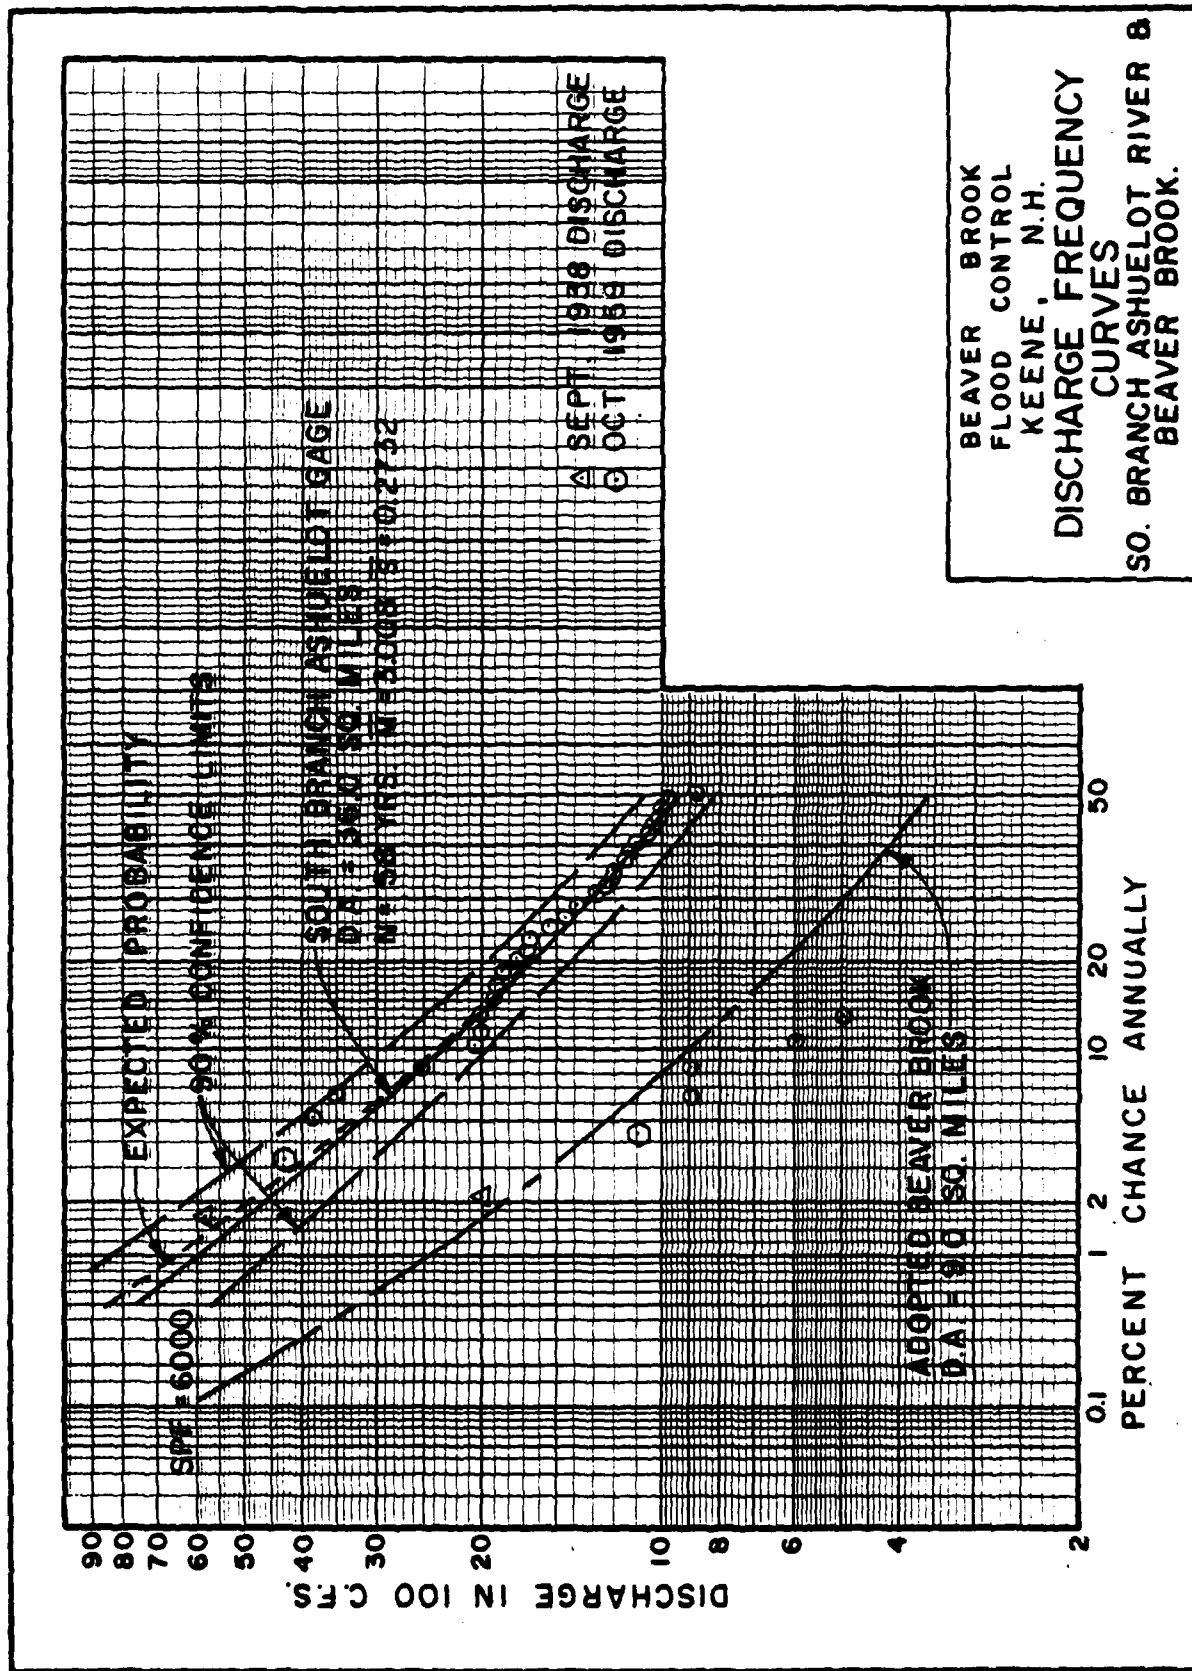
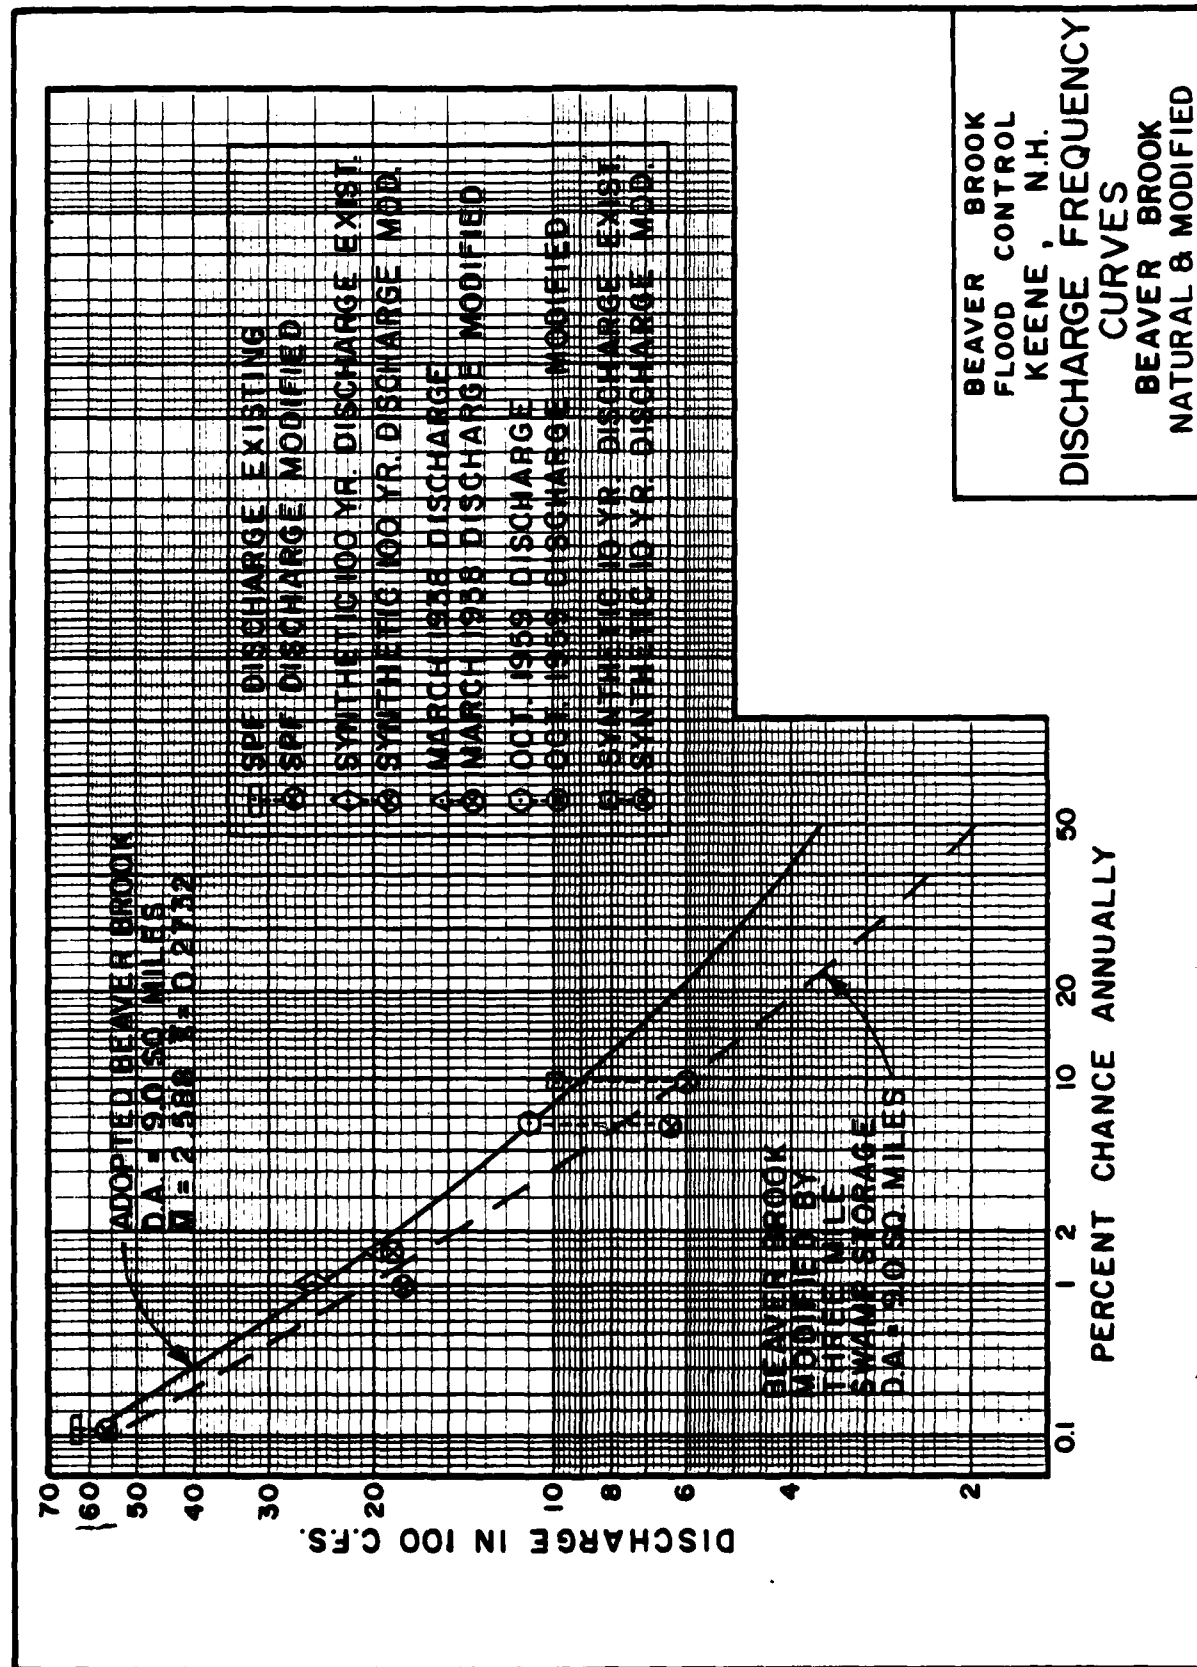
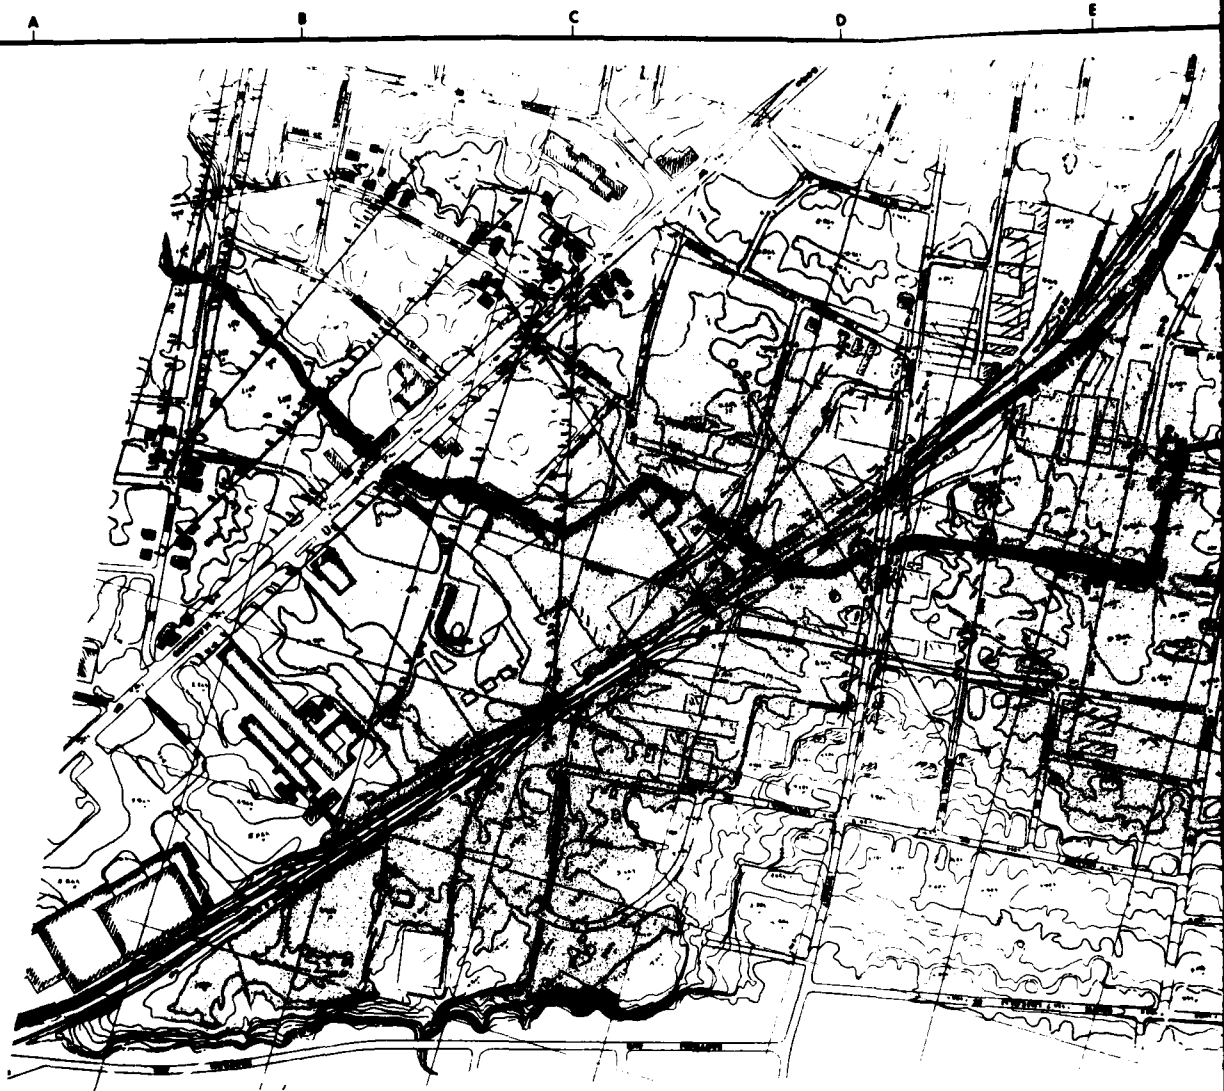
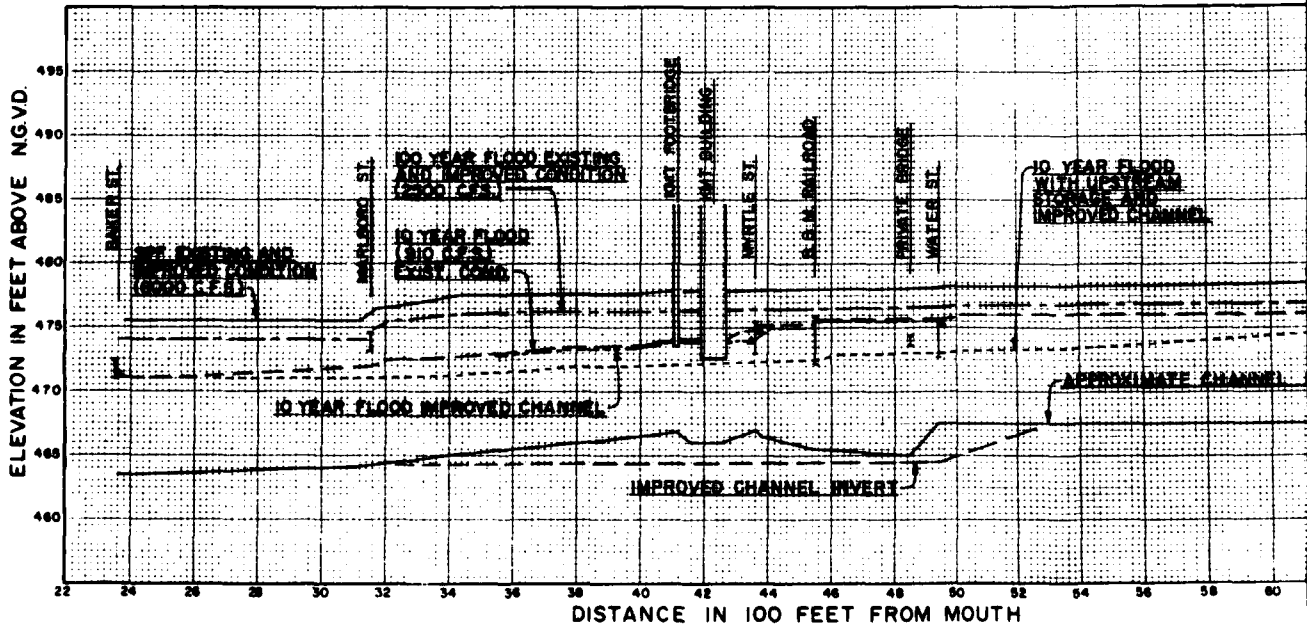
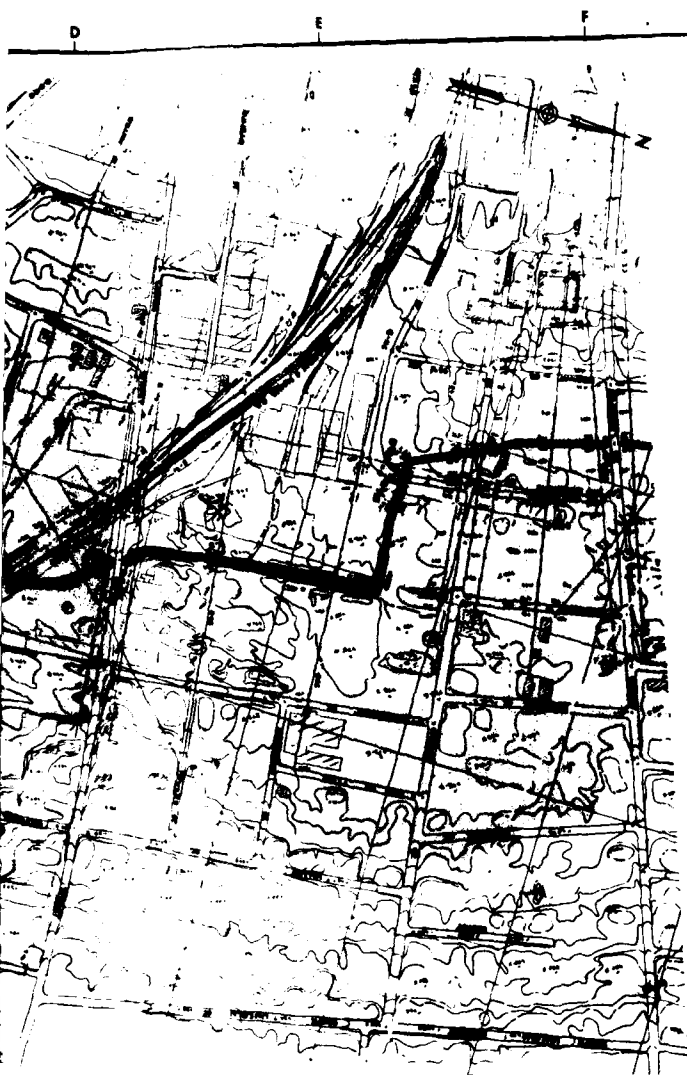
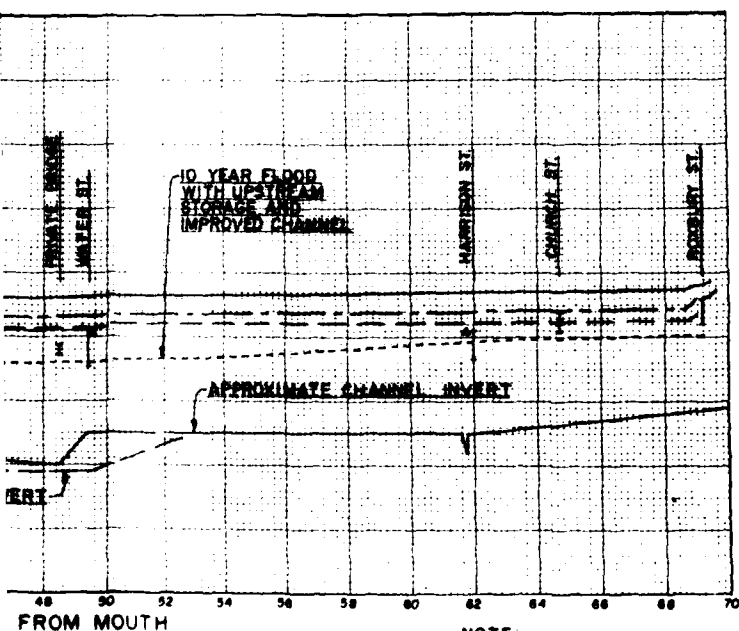
PLATE A-7

▲ DECEMBER 1973 HIGH WATER MARK

ASHUELOT RIVER BASIN
BEAVER BROOK KEENE, N.H.
PLAN & PROFILE
EXISTING & IMPROVED CONDITIONS
HYDRO. ENG. SECT. FEB. 1983

Flood profiles and stage-discharge relationships for Beaver Brook were computed utilizing the backwater computer program, HEC-2, and conventional hydraulic formulae. Backwater computations were made using cross sectional surveys developed by Anderson Nichols Company during the "Keene Flood Plain Management Study". Analysis extended from downstream of Marlboro Street to upstream of Harrison Street. Backwater computations were made for both natural and modified conditions using a Manning's "n" of 0.032 for the channel and ranging from .045 to .06 for overbank flow areas. Assumed contraction and expansion loss coefficients were, respectively, 0.3 and 0.5. A starting stage-discharge relationship was developed downstream of Marlboro Street using backwater data developed in the earlier "Keene Flood Plain Management Study". Computed natural and modified profiles plus established December 1973 high water elevations are shown on plate 7.

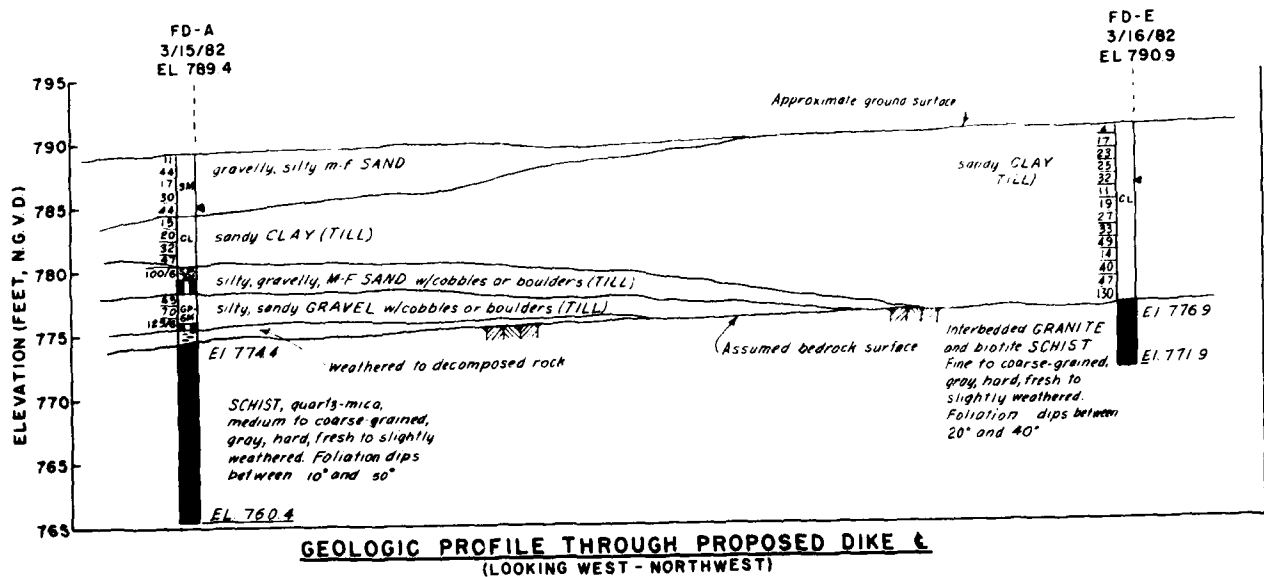
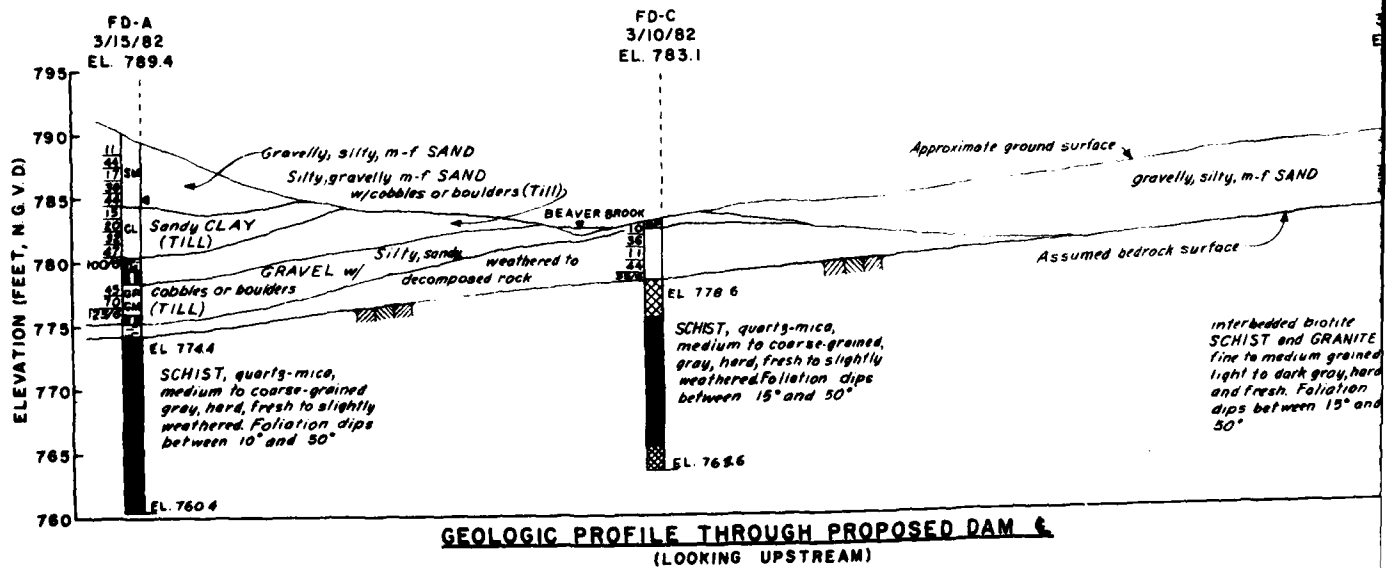
1. Boundaries between materials are approximate.
2. Topsoil cover, up to one foot thick, not shown

PLAN OF EXPLORATIONS AND GEOLOGIC LOG PROFILE

c. Dam and Dike Foundations. As indicated by the Geologic Log Profile on Plate B-1, the overburden varies from about five feet in thickness on the left abutment to only one foot in the vicinity of the existing brook to about 15 feet adjacent to the highway embankment and under the proposed Dike A embankment. The overburden materials consist of a capping of about 6 to 12 inches of topsoil and forest litter overlying primarily glacial materials which in turn overlie schist and granitic bedrock.

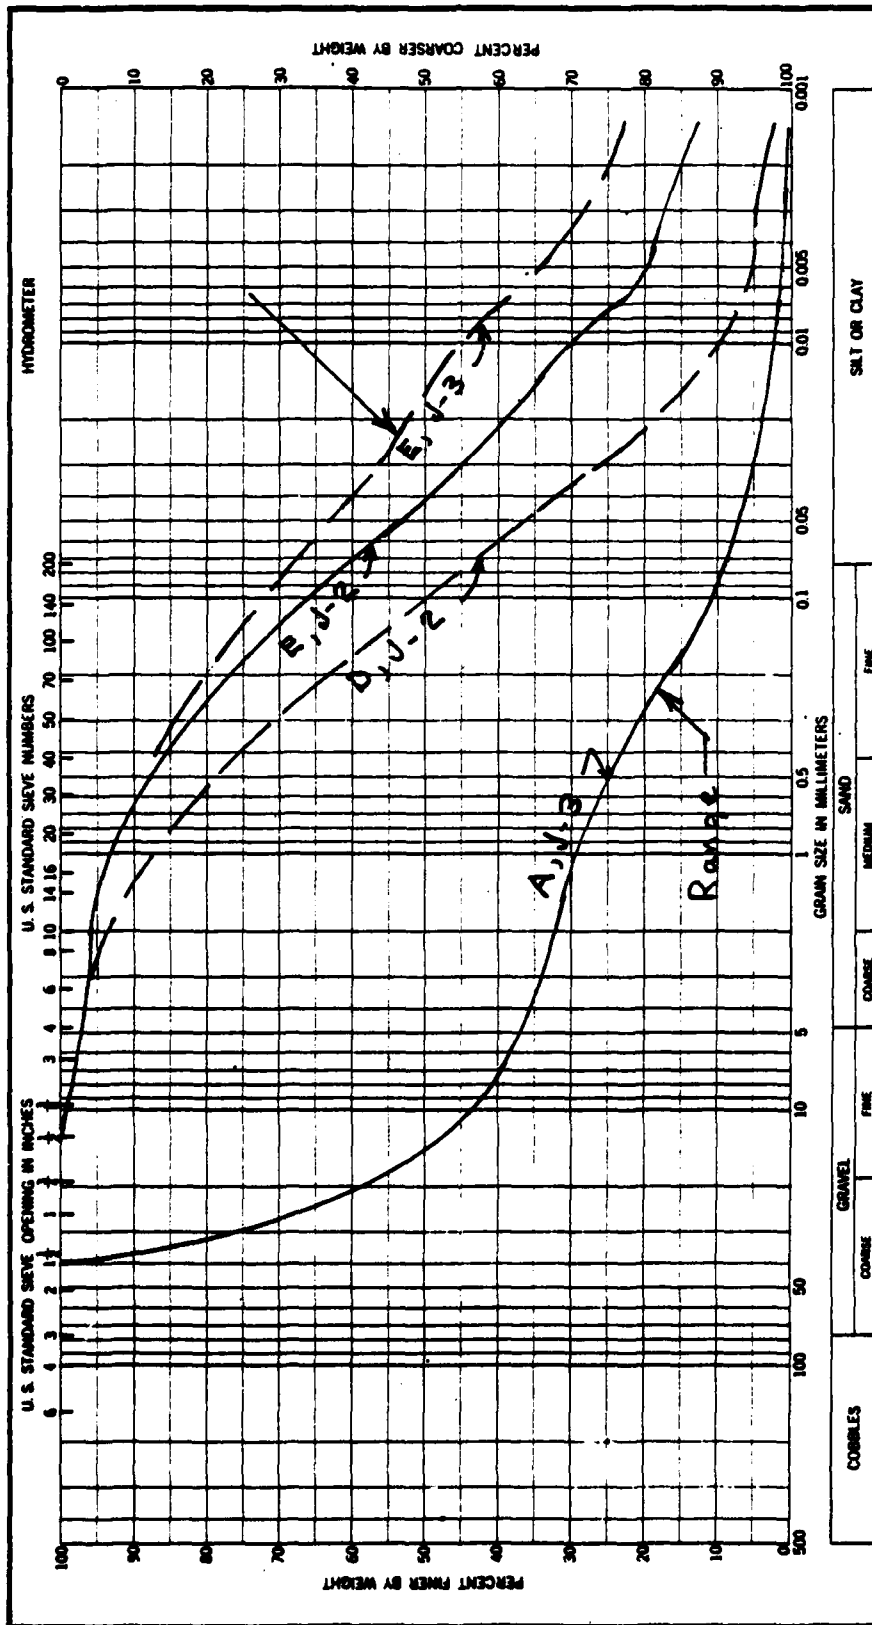
Project: Beaver Brook L.P.P.		Date: Feb. 1983	
Selected Test Data		Foundation Materials	
Dam & Dike A			
Sample No.		Classification	
Elev or Depth		Not w %	
		LL	
		PL	
		PI

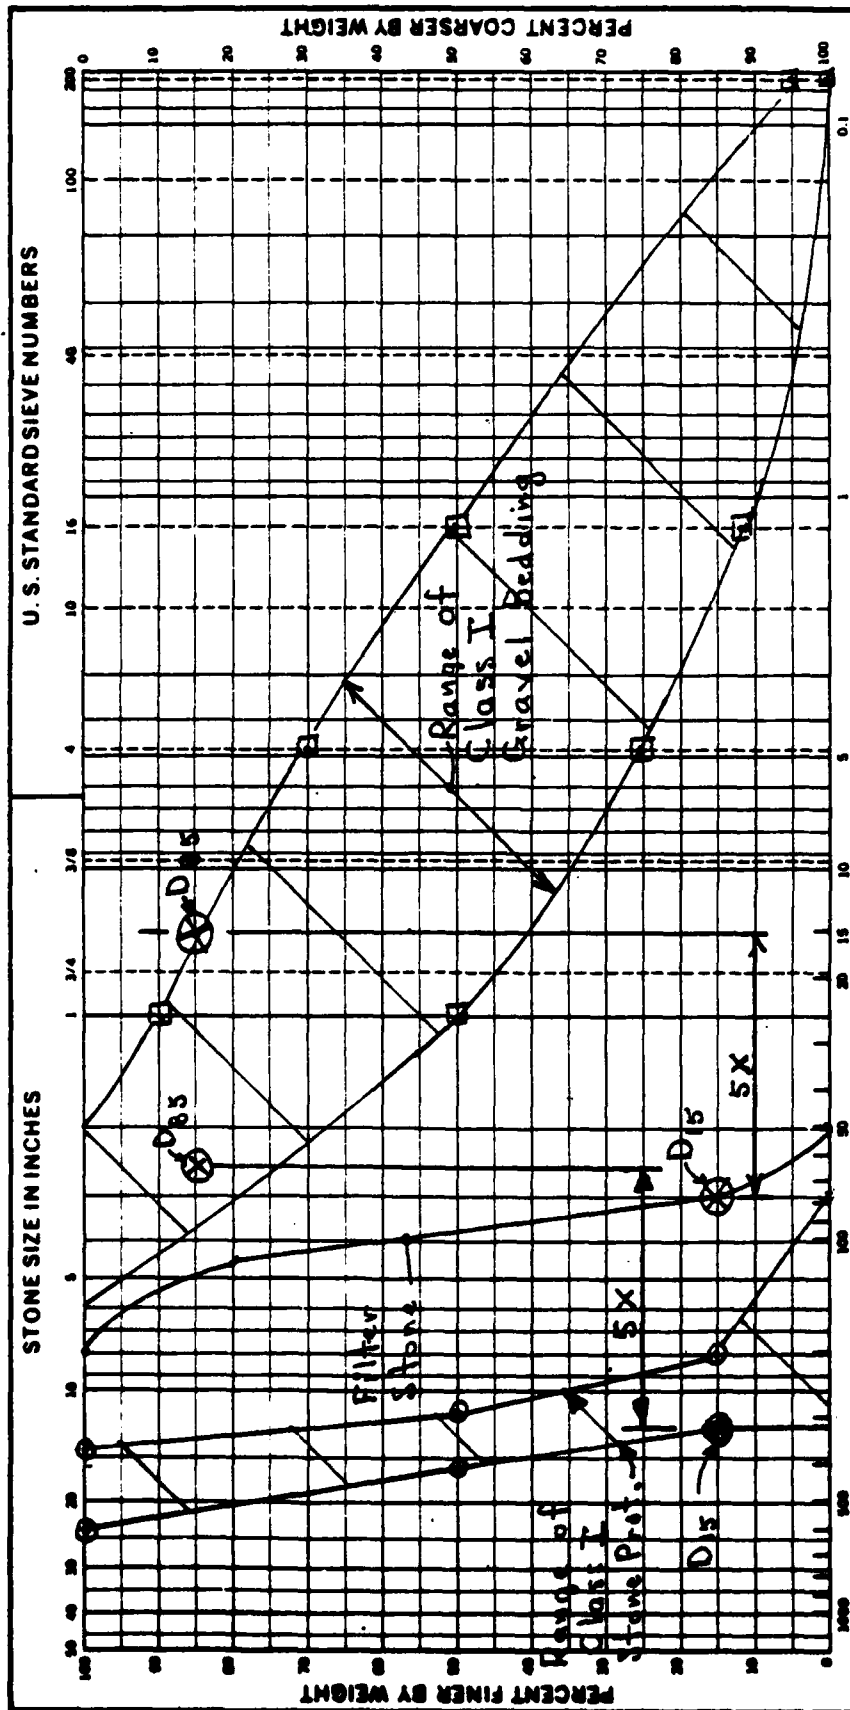
SPECIFIC GRAVITY OF STONES...2.65

PROJECT Beaver Brook L.P.P.
 AREA Filter Studies - Stilling Basin
 DATE Feb. 19.83
 GRADATION CURVES
 FOR RIPRAP FILTER AND BEDDING
